4 Seasons Home Inspections

Property Inspection Report

78530 Wonder ave , Sample, WA 98000
Inspection prepared for: Ever Best Client
Date of Inspection: 2/1/2018 Time: 9:00 AM
Age of Home: 2008 Size: 7635
Weather: Raining; Temperature is 45 degree
Report # sample

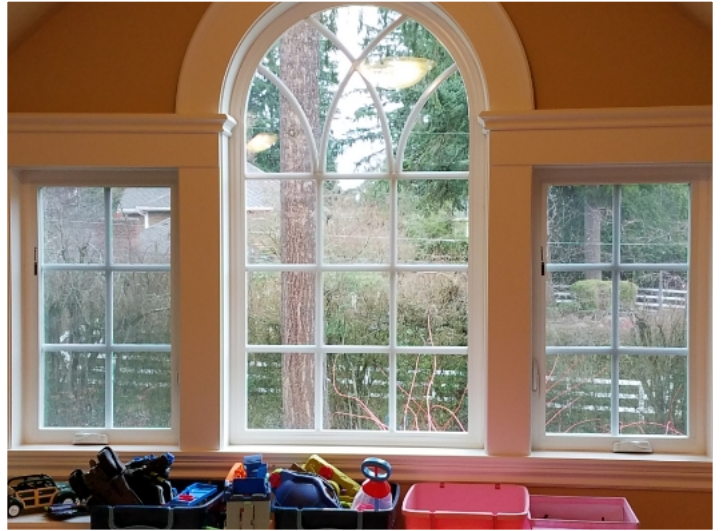
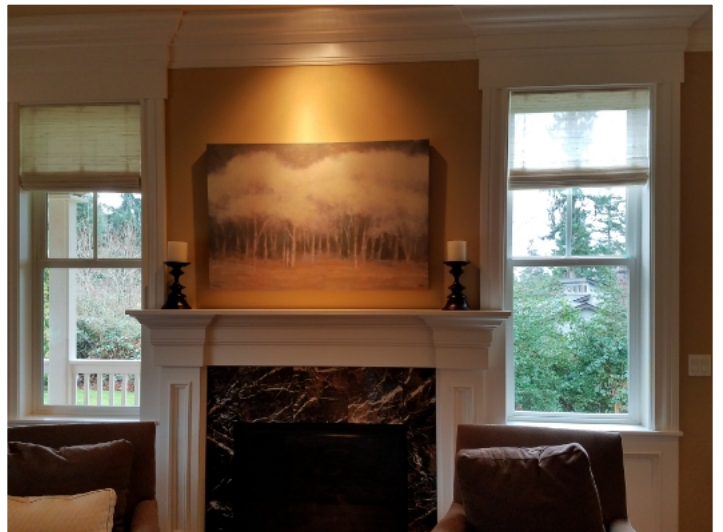
- Operated windows appeared functional, at time of inspection
- Missing screens at a few locations.
- One or more windows did not lock/latch properly, recommend repairs for enhanced security/safety to occupants.
- Broken sash wire/cord observed on window frame. This is a "Safety Concern". Sash wire/cord holds window in open position. Suggest repairs/replacement as needed to ensure safety.
- Splintered frame on window near patio door. Recommend repair or replacement.
- One window shows sign of loss of seal/condensation in the living room near the fireplace. recommend repair or replace to provide energy savings and prevent hazed window from limiting view out of window.

Missing cover

Missing screens

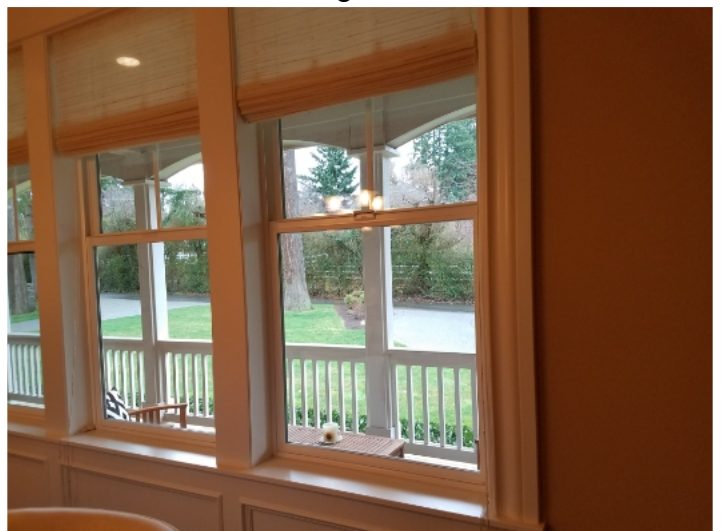
Split & sash

Latch not working

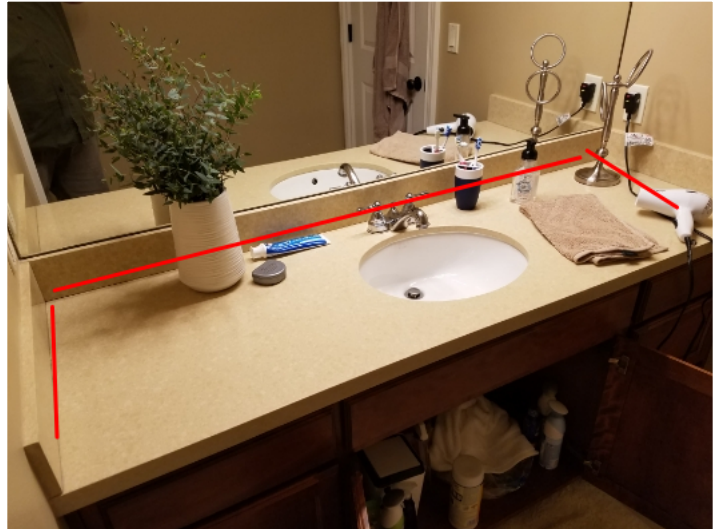
- **Recommend caulking backsplash at countertop. It appears to be missing.**

Recommend caulking

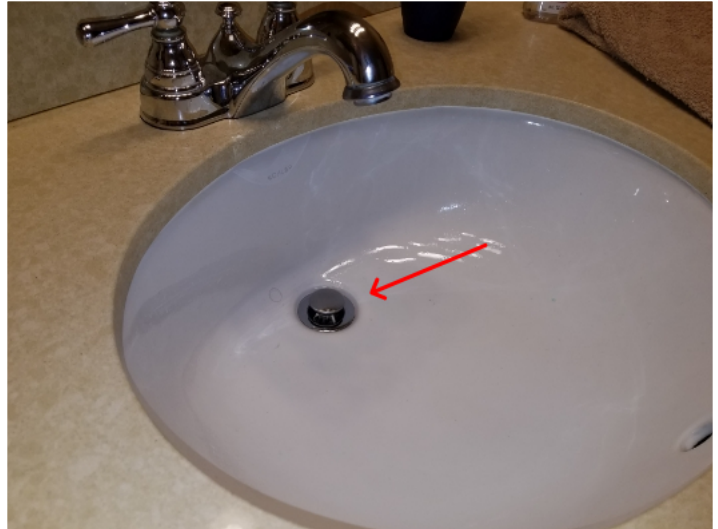
- The stopper to the sink in the lower basement bathroom does not stay closed. Recommend adjusting sink stopper.
- There's a small leak in the connection to the P-trap in the lower basement bathroom sink. Recommend repair.

the drain leaks

stopper will not stay shut

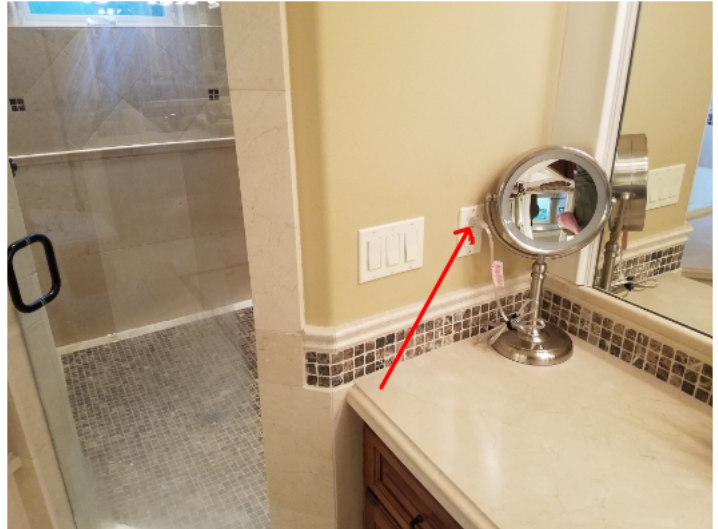
- There is a grounding prong broken off inside of the lower outlet in the master bathroom near the shower. Recommend repair.

broken prong stuck inside

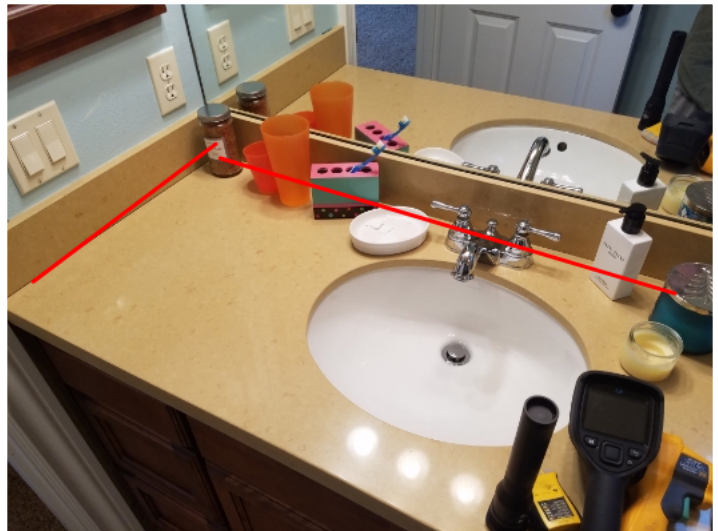
Observations: Solid Surface tops noted., **The caulking in the backsplash of the counter tops is split and in need of repair.**

Recommend caulking

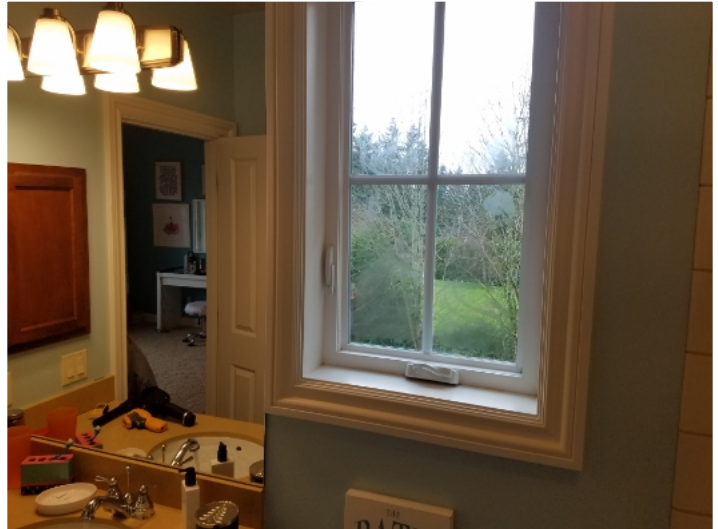
Observations: Upper front bathroom window shows sign of loss of seal/condensation, recommend repair or replace to provide energy savings and prevent hazed window from limiting view out of window.

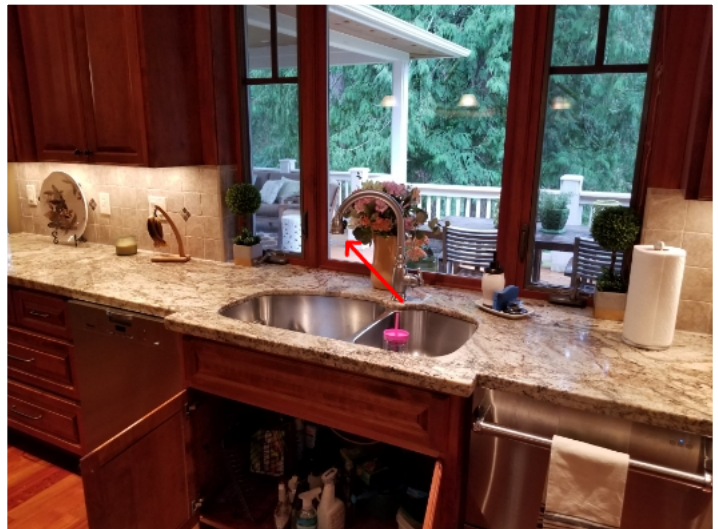
- The button for the spray wand is damaged.

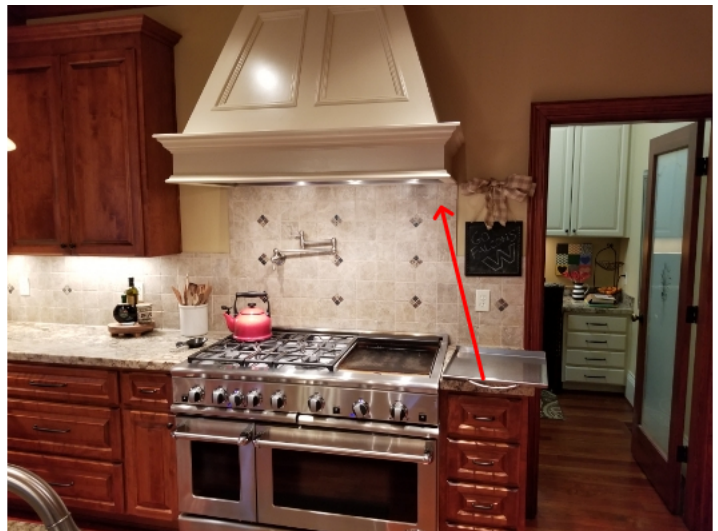
- The exhaust vent on the right hand side is inoperable. Recommend repairs.

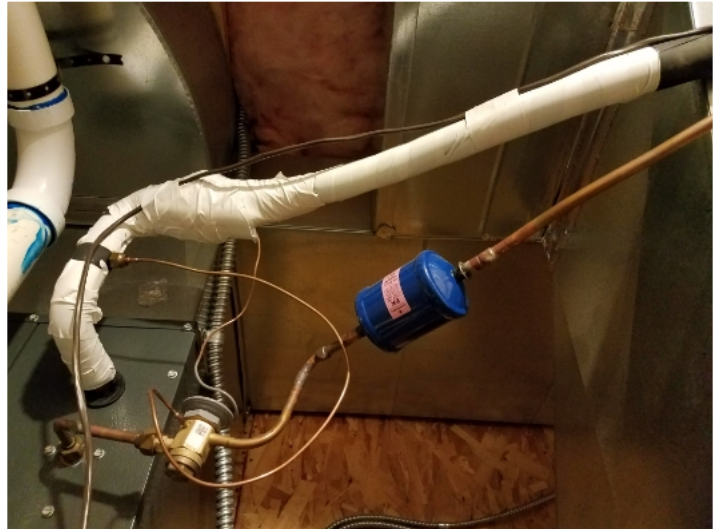
Observations: Missing insulation at A/C unit., Missing insulation at the furnace.

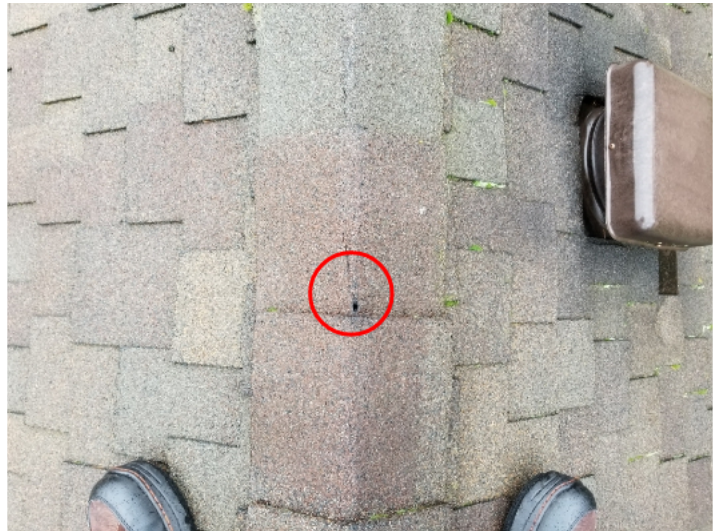
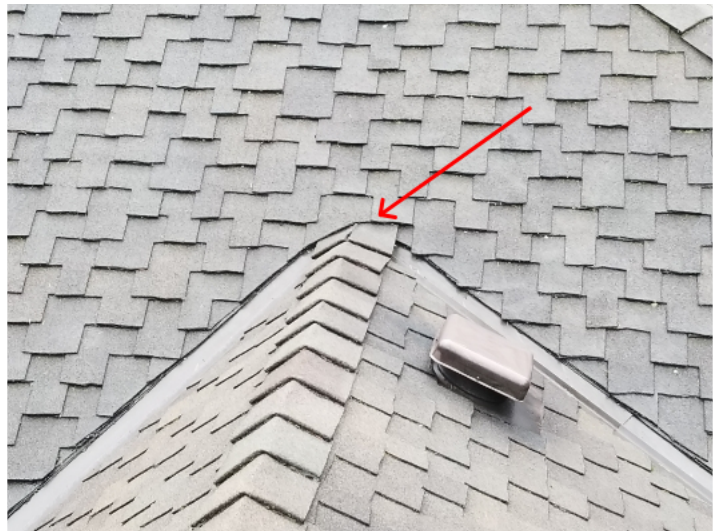
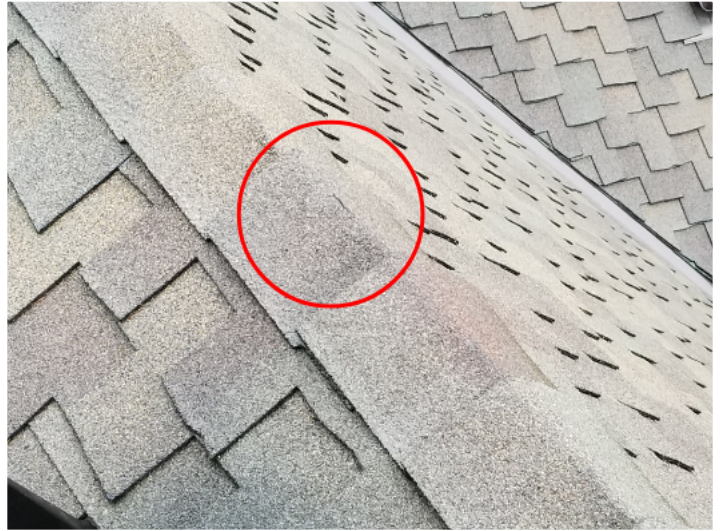
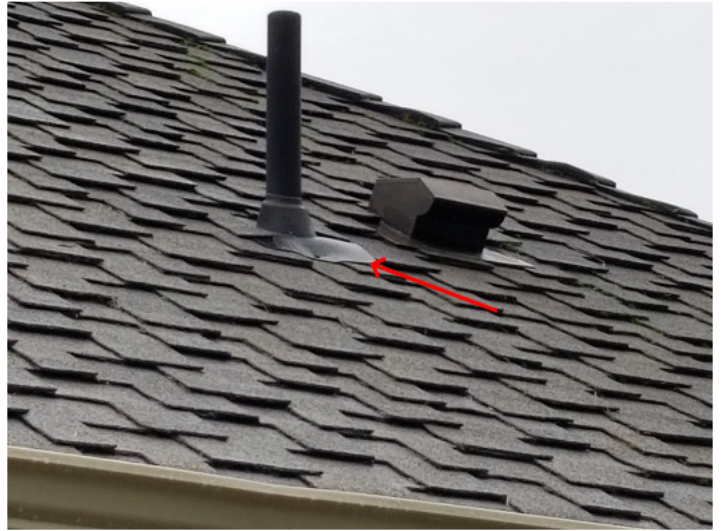
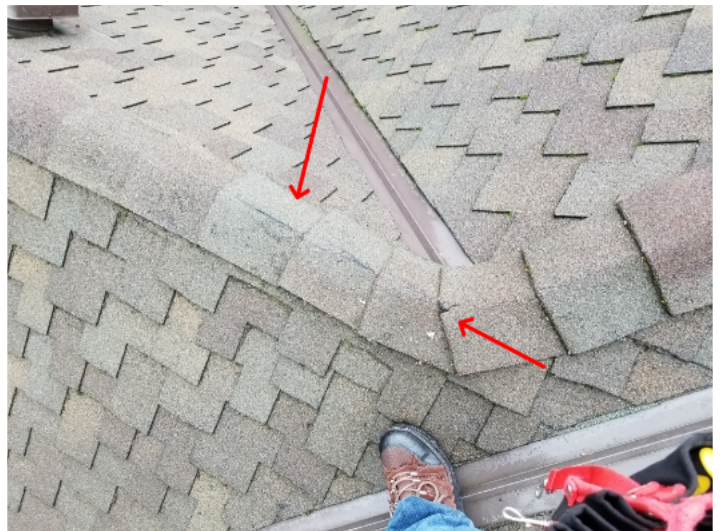
- Plumbing boots are puckered recommend correcting this issue.
- Ridge cap is damaged. Recommend repairs

Puckered plumbing boot.

Damaged ridge cap.

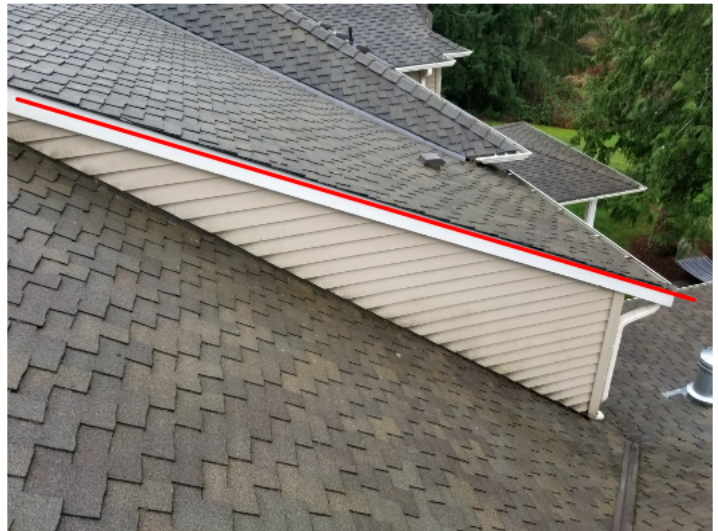
Missing kick out flashing.

Missing rake flashings.

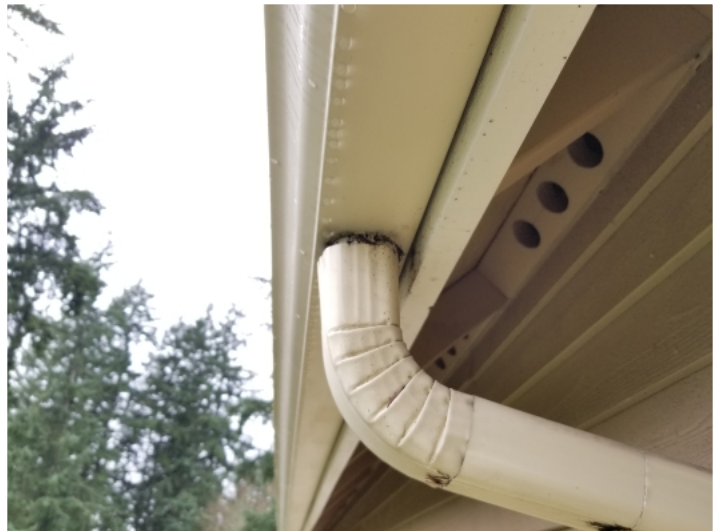
- There appears to be water leaking from the corner of the back gutter. Recommend correcting this issue.
- Recommend connecting downspout to the gutter. This was noted at the left side of the house.

Downspout appears to be clogged and full of water.

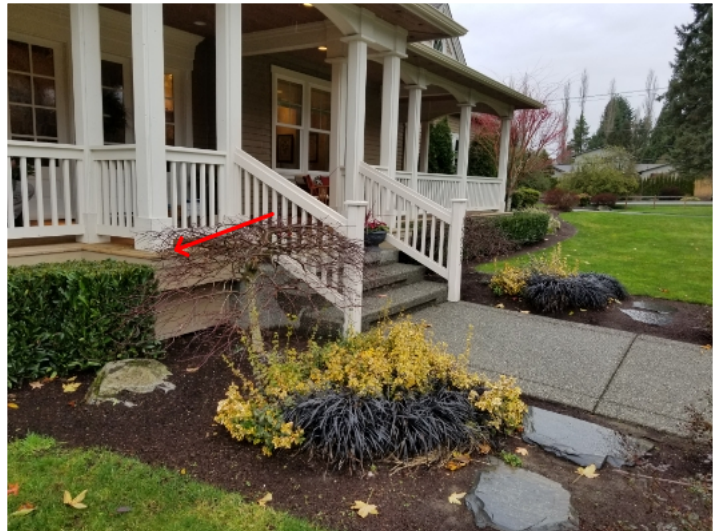
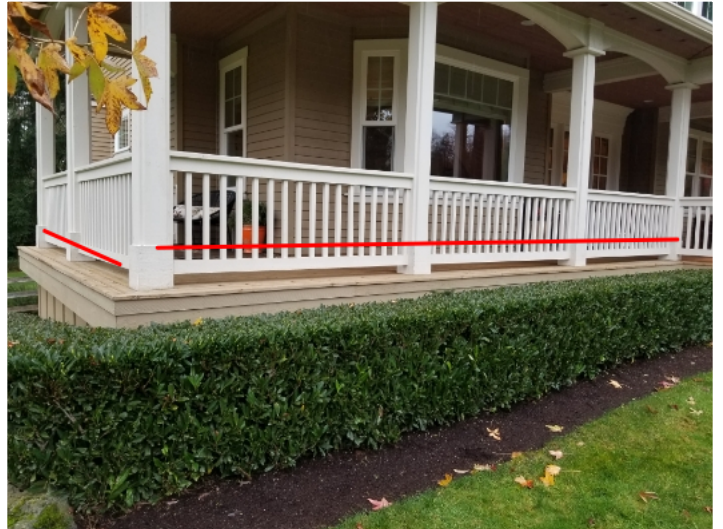
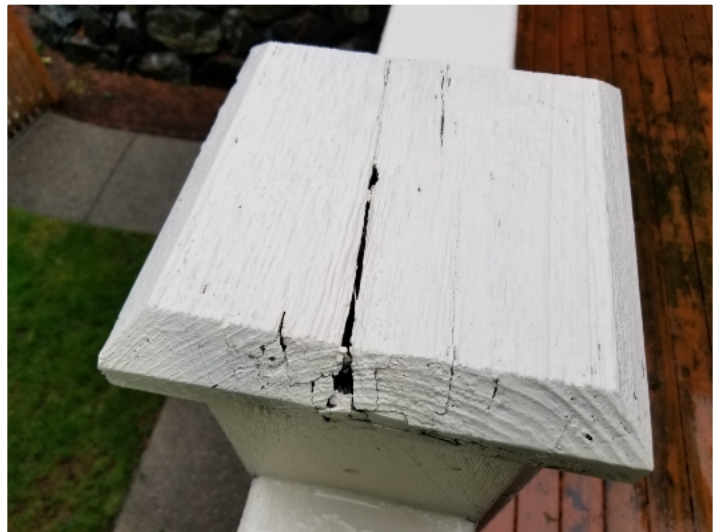
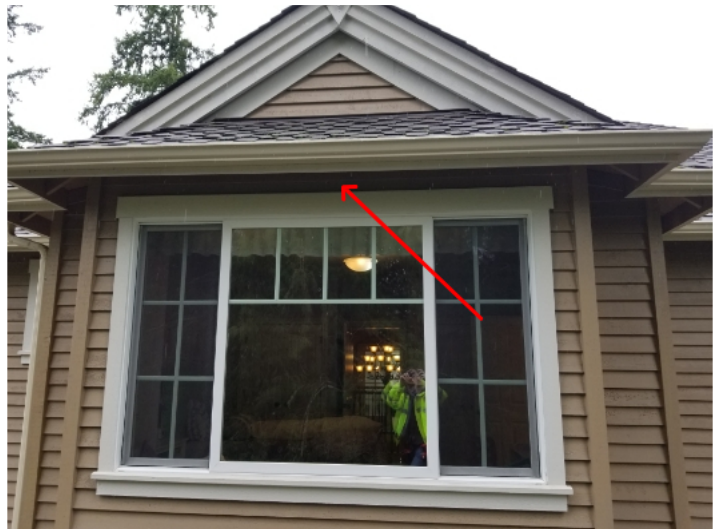
- Trim at the back left side of the house is loose. Also there is Earth to Wood contact at the trim.
- Rot was noted at the front porch just left of the stairs.
- Recommend caulking the post wraps at the front porch.
- One of the post caps at the back deck is showing signs of rot.
- Broken bird block at the back of the house.

Wood rot.

Cracked bird block.

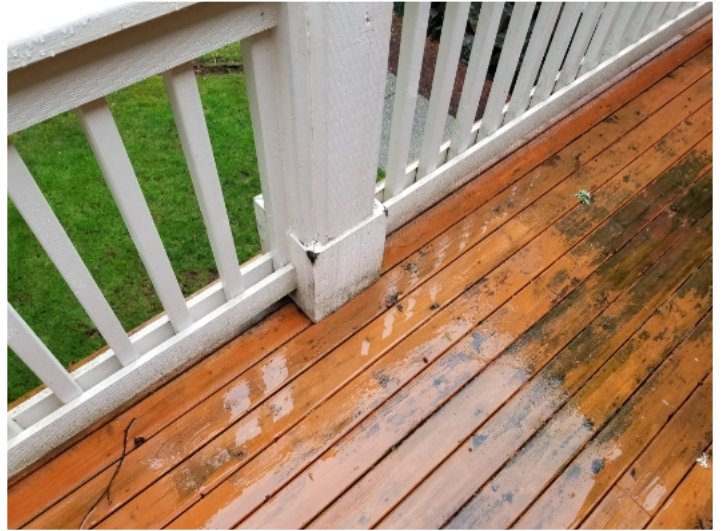
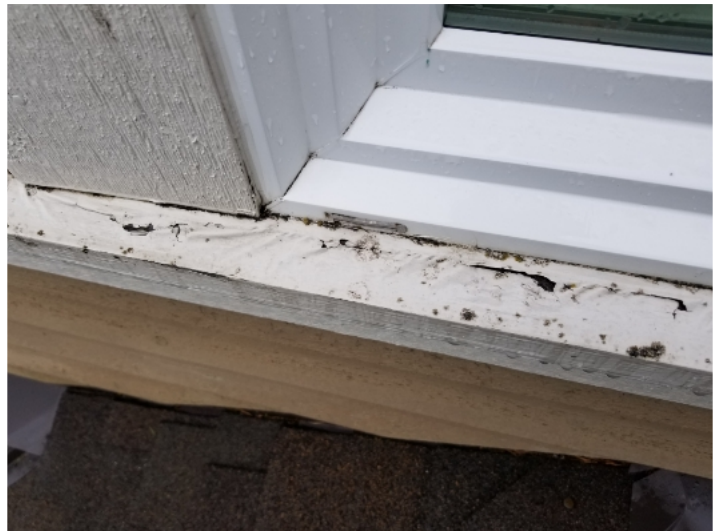
- Peeling paint observed at a few trim areas, suggest scraping and painting as necessary.
- Missing paint was noted in a few areas.
- There is some missing paint at the back deck.

Missing paint and some of the wood is starting to deteriorate.

Front of the house over the porch roof.

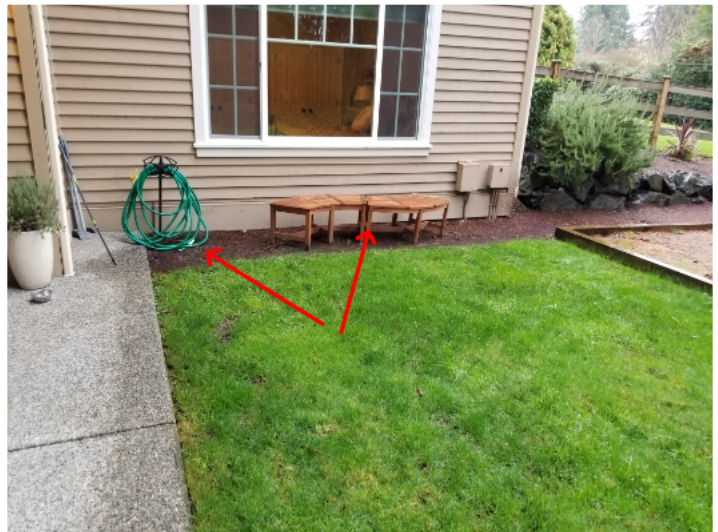
- There is earth to wood contact around front porch. This condition can lead to conducive conditions that cause woos rot or attract pest such as termites or moisture ants to the dwelling. Recommend all dirt be no closer than 6 inches from touching siding.
- Lot grading and drainage have a significant impact on the building, simply because of the direct and indirect damage that moisture can have on the foundation. It is very important, therefore, that surface runoff water be adequately diverted away from the home. Lot grading should slope away and fall a minimum of one (1) inch every foot for a distance of six (6) feet around the perimeter of the building.
- There is Earth to Wood contact at the back of the house recommend correcting this issue.

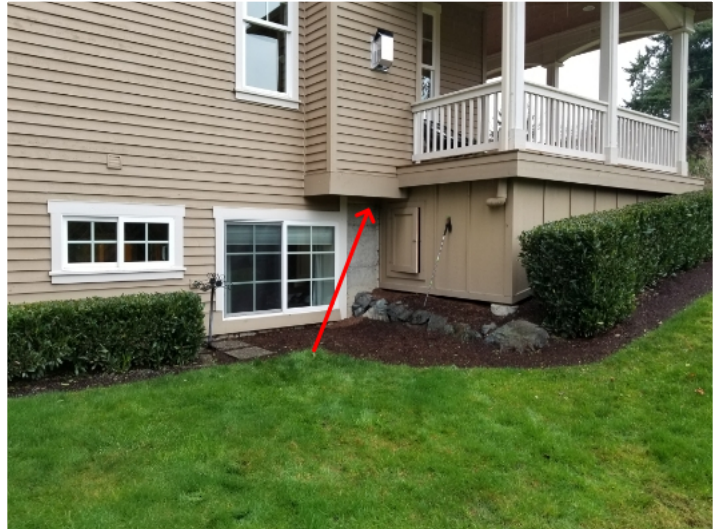
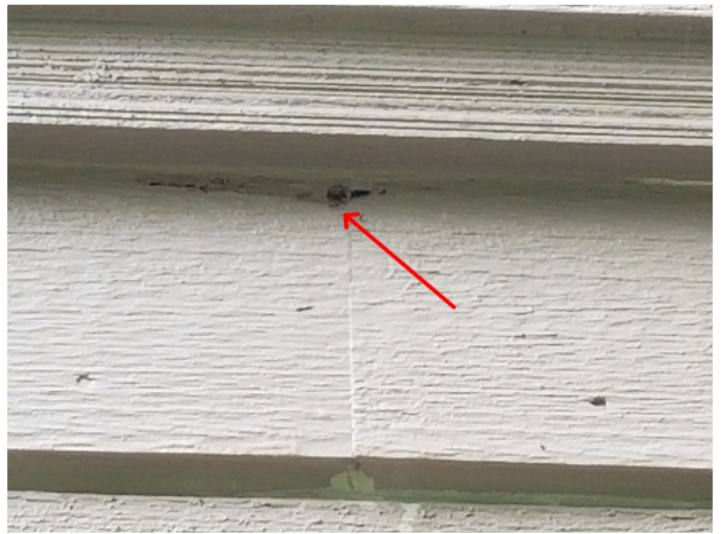
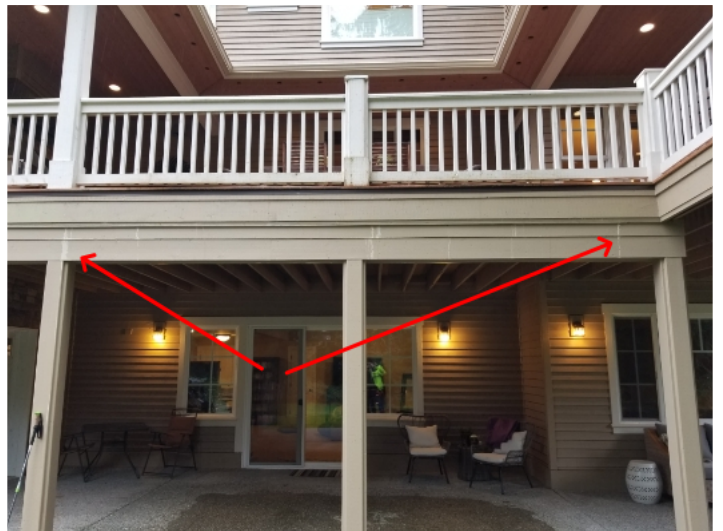
- Recommend adding a post underneath the deck beam at the left hand side of the front deck.
- One of the Joists is missing a hanger and is being held up with nails and A35 recommend correcting this issue.
- Water appears to be running through the cracks of the trim at the back of the deck. Some of the trim wood was noted as being soft and starting to deteriorate.
- Some of the paint is worn form the deck surface.

Trim is starting to show signs of rot.

The water coming through the trim is causing the paint to run.

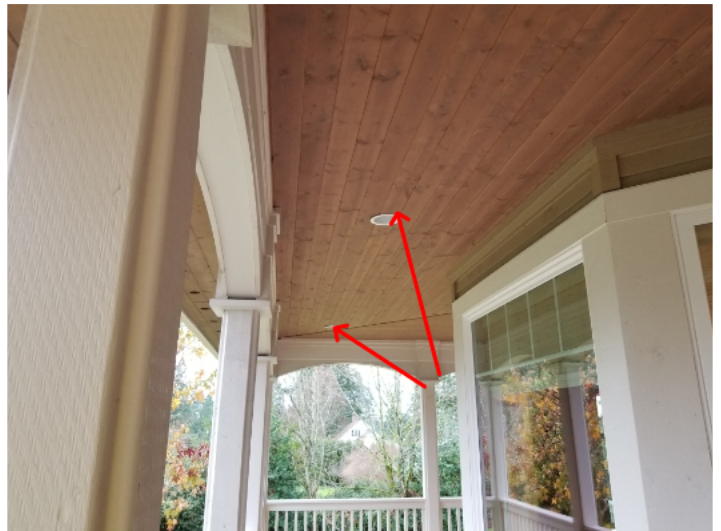
- There are a few burnt out light bulbs and the front porch.
- A few of the bulbs in the driveway lights are burnt out.
